SEWER PUMP STATION INSPECTION REPORT

Asset ID	Wahroonga Pump Station
Asset Location	Wahroonga Street Biloela
Special Access Requirements	In open space - Contractor Vehicle parking next to pump station

Date of Inspection: July 2022

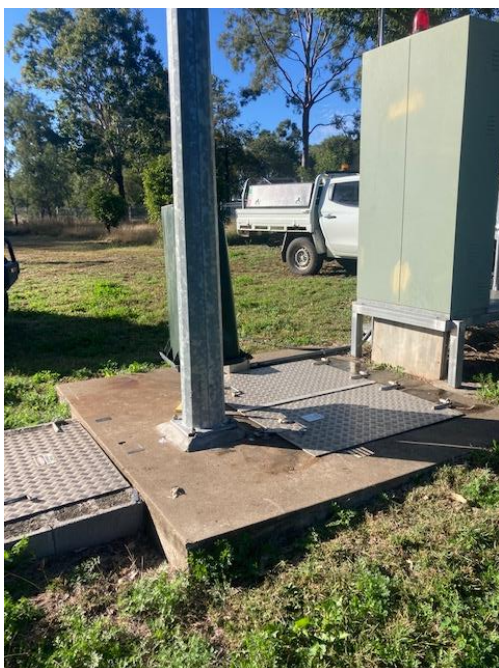
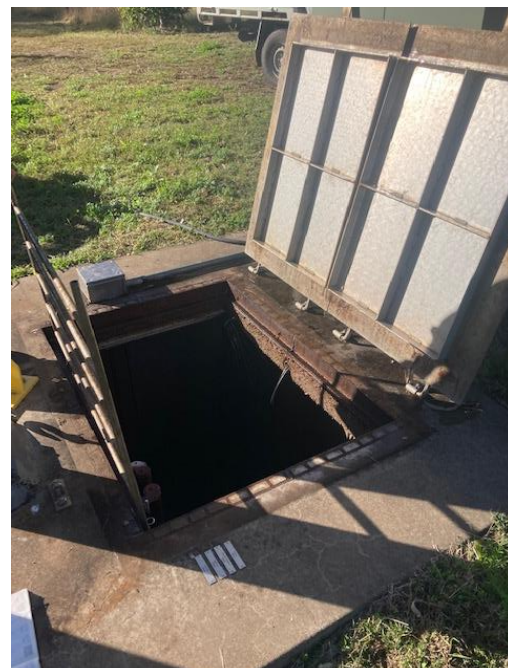
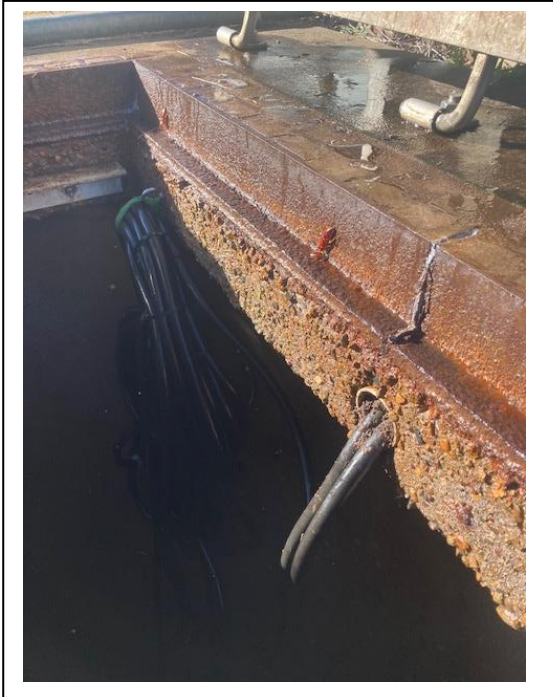
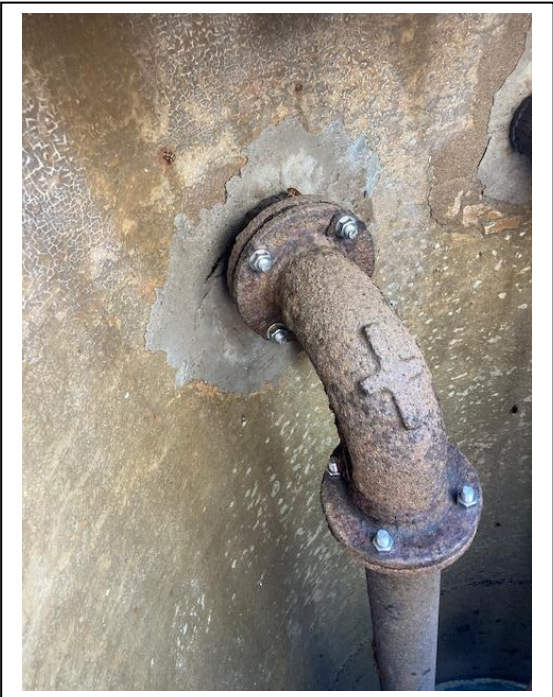
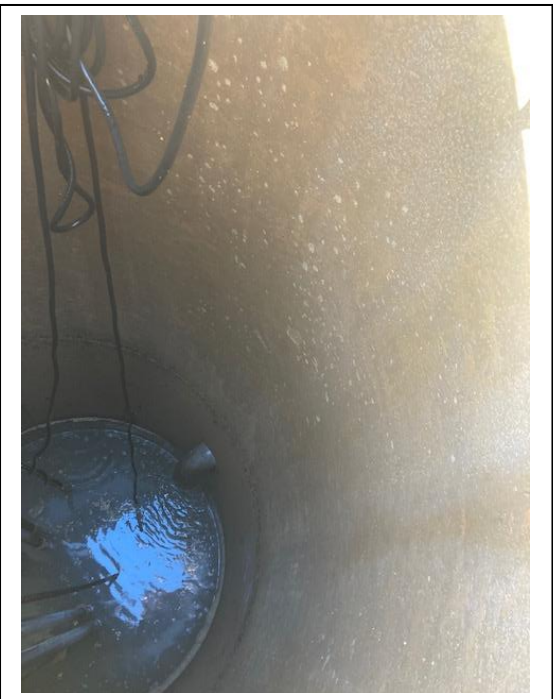
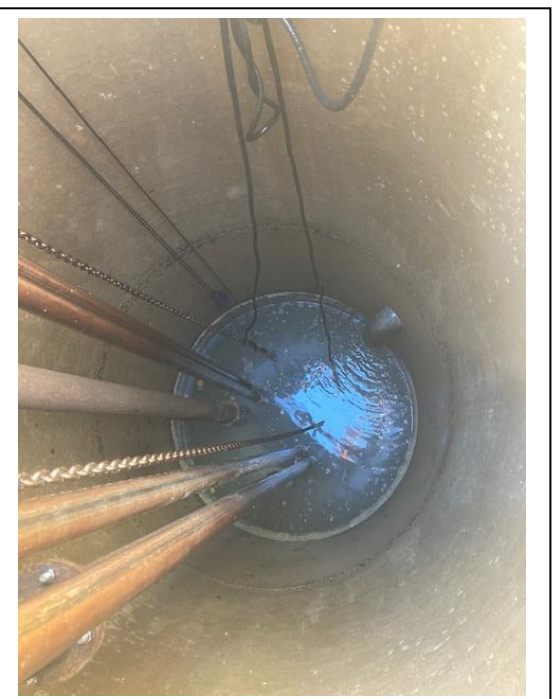
Relining required to depth of (mm)	5700mm
Diameter (mm)	1800mm
Concrete Repairs to Walls	No
Embedded Steel Treatment/Repair	No
Rust Treatment and Coating of Pipes and Flanges	3
Pipe Penetration Repair	No
Chamber Wall Condition (Class)	3
Existing Surface Profile	10 – 15mm

Medium

Pump Station to be relined in live condition

Soffit and edge of access hatch to be relined as well as all walls to depth as nominated
