(AMENDED 15 SEPTEMBER 2020) Negotiated Decision Notice about request to change development approval

Combined application for Material Change of Use - Public Facility - Other (Solar PV Power Station (Solar Farm) and Associated Switchyard and Electrical Transmission Line) and Reconfiguring a Lot for Subdivision by Agreement(10 Lease Areas)
Rural Zone Code
Natural Features and Conservation Areas Overlay Code Economic Resources Overlay Code Major Utilities Overlay Code Natural Disaster Overlay Code Development Standards Code
Reconfiguring a Lot Code
Rural Zone Code - The development complies or has been conditioned to comply with all applicable Outcomes.
Natural Features and Conservation Areas Overlay Code - The development complies or has been conditioned to comply with all applicable Outcomes.
Economic Resources Overlay Code - The development complies or has been conditioned to comply with all applicable Outcomes.
Major Utilities Overlay Code - The development complies or has been conditioned to comply with all applicable Outcomes.

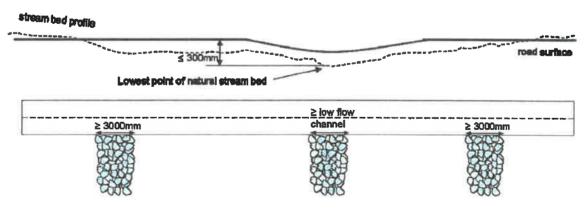
Figure 5 Purple and red option two (no low flow section incorporated)—cross section and plan view

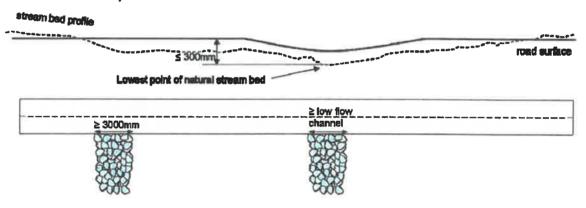
Figure 7 Amber option two (no low flow section incorporated)—cross section and plan view

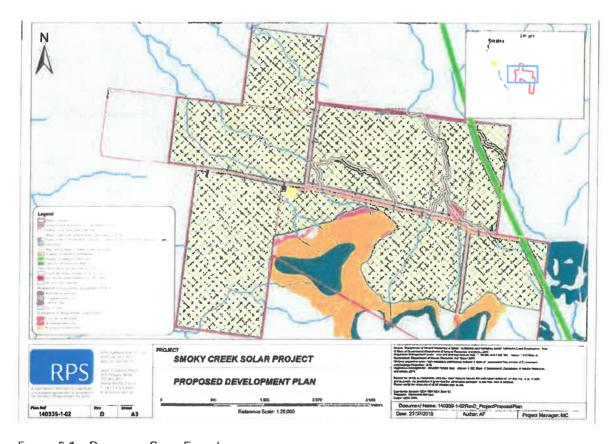
Figure 2-1 - Proposed Solar Farm Location

The site more specifically referred to as part of Lot 39 on RN395, Lot 28 on RN211, Lot 18 on RN271 and part of Lot 37 on RN1147 will host a large-scale solar photovoltaic (PV) generation facility and associated infrastructure. The project will occupy an area of approximately 2113 ha over the site and produce in the order of 500MW.

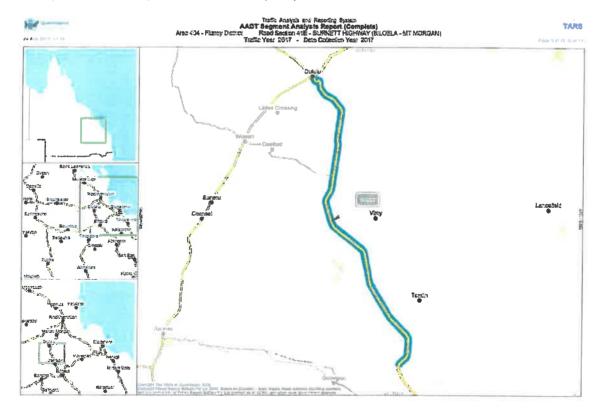
Figure 2-4 - TARS Data - Road Section 41E (Burnett Highway)

Current traffic volume data for the Burnett Highway (41E) were obtained through the Rockhampton office of the Department of Transport and Main Roads (TMR).

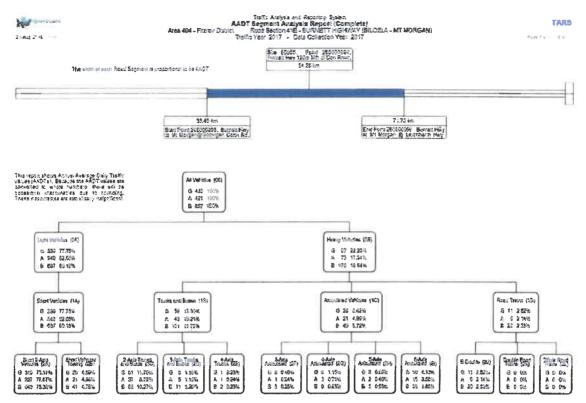
Figure 2-5 - TARS Data - Road Section 41E (Burnett Highway)

All Traffic Analysis and Reporting System (TARS) data relied upon have been included within Appendix A.

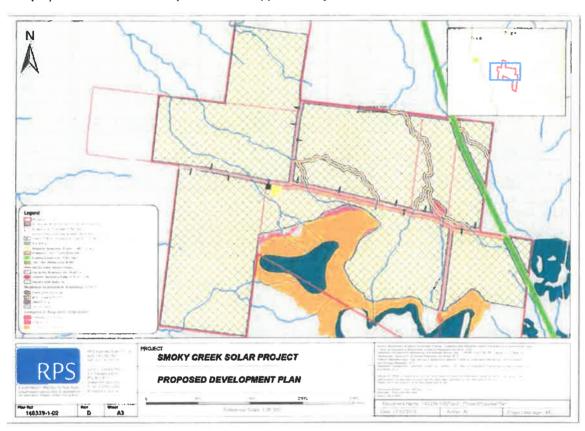
Figure 3-1 - Proposed Development Envelope

The proposed solar farm development area is approximately 2113 ha.

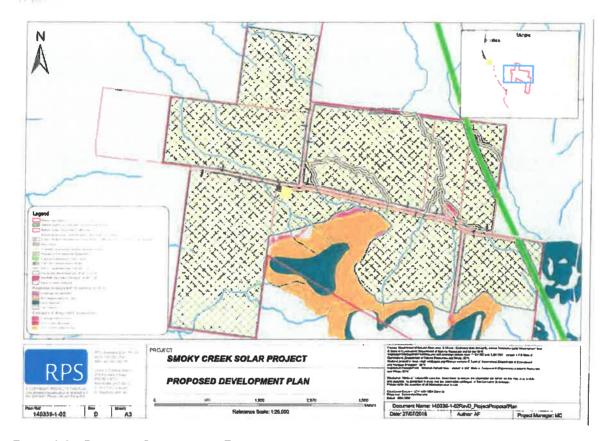
Figure 3-2 - Proposed Development Envelope

Preliminary layout plans of the facility are provided below.

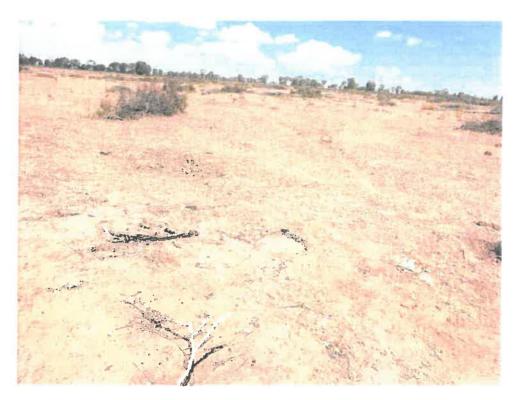
Photograph 5 View to the south of low groundcover due to drought conditions
