Pavement Design Report

Jambin – Goovigen
Road Floodway

Final Report

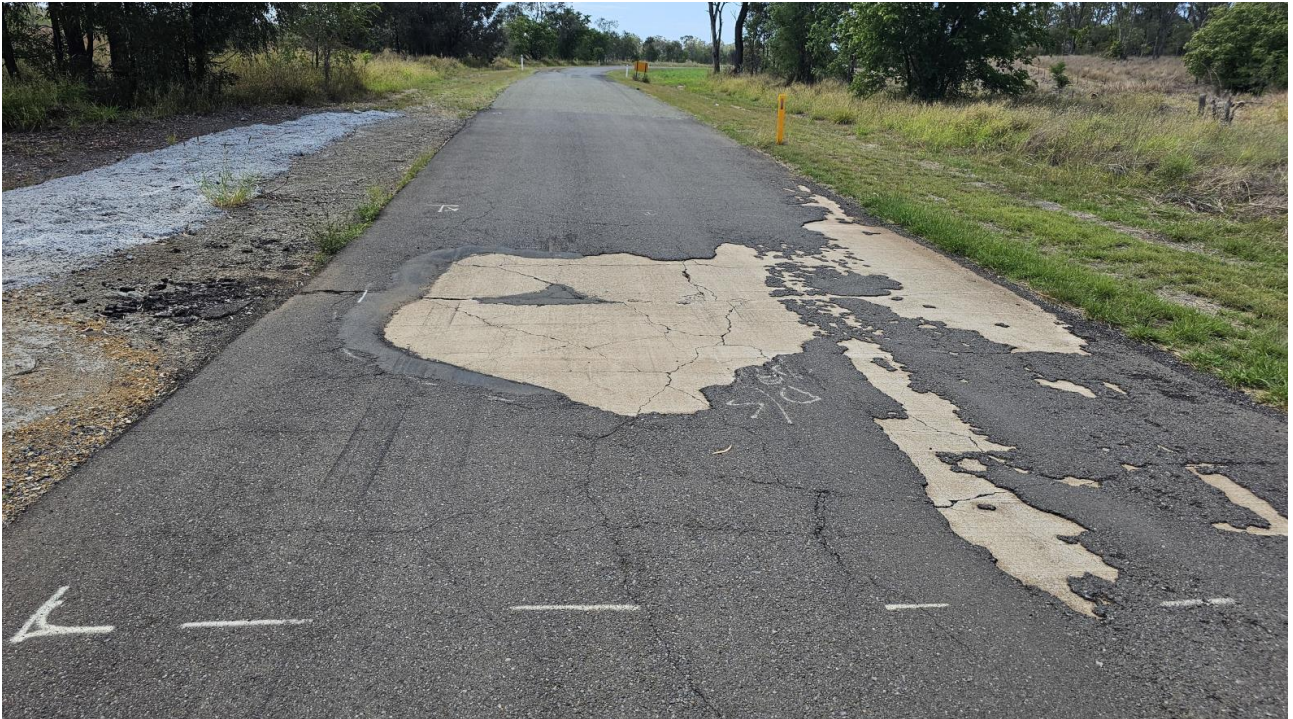
Figure 2 - Existing condition of concrete floodway pavement

The existing concrete pavement in the middle of the floodway is in poor condition, with significant cracking and displacements. Asphalt surfacing over the concrete has been lost in some areas. A photo of the existing concrete floodway condition is shown below.

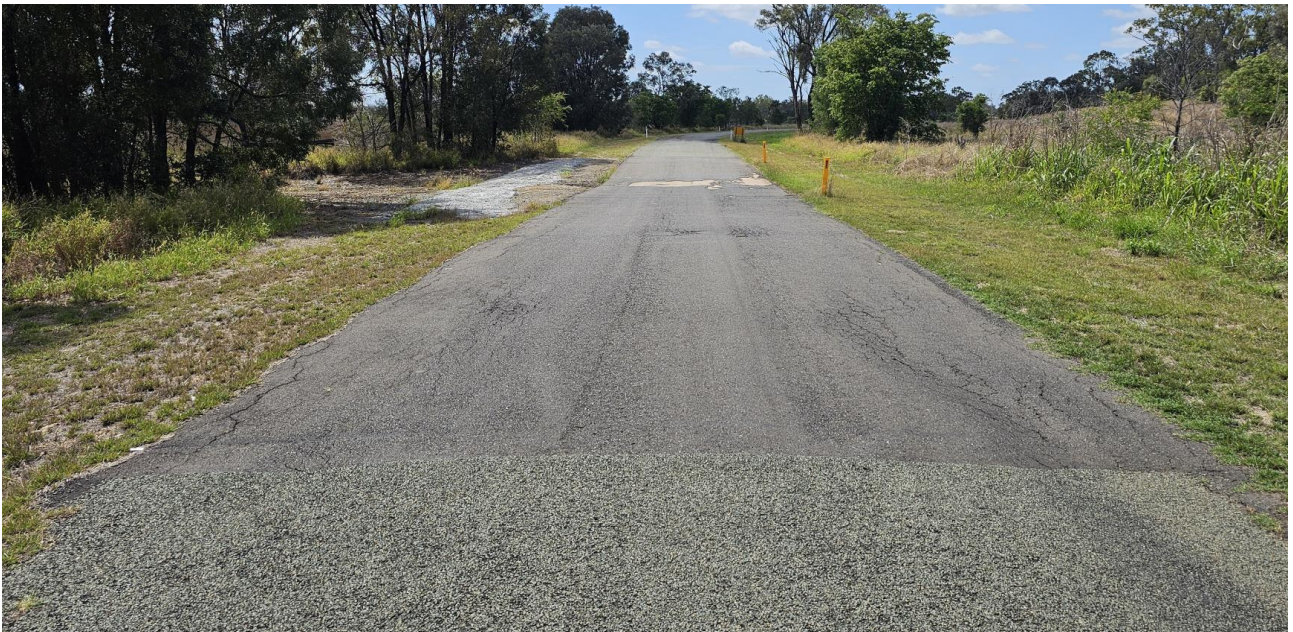
Figure 3 - Existing condition of road approaches

The road approaches to the floodway are also in poor condition, with significant cracking, rutting and loss of shape. These defects indicate the existing pavement depths and material quality are inadequate for the subgrade support conditions. A photo of the existing pavement condition of the road approaches is shown below.

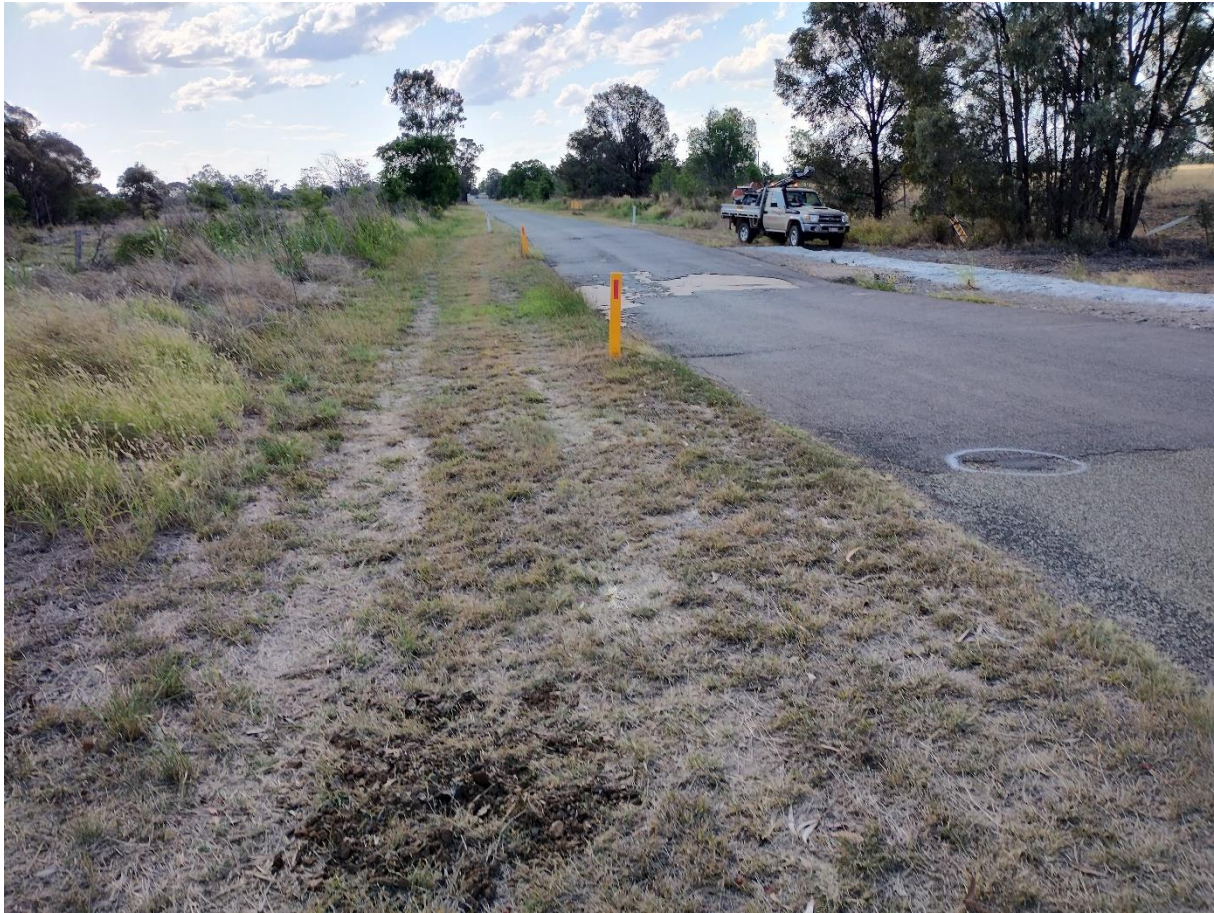
Figure 1: Typical site conditions

The photograph in Figure 1 indicates typical site conditions at the time of investigation.
