# Pavement Investigation

## Testpit Logs and DCP Test Results

**SITE ADDRESS:** Proposed Road Upgrades  
Tomlins and Dodsons Road, Goovigen

**Job Number:** CQ30079

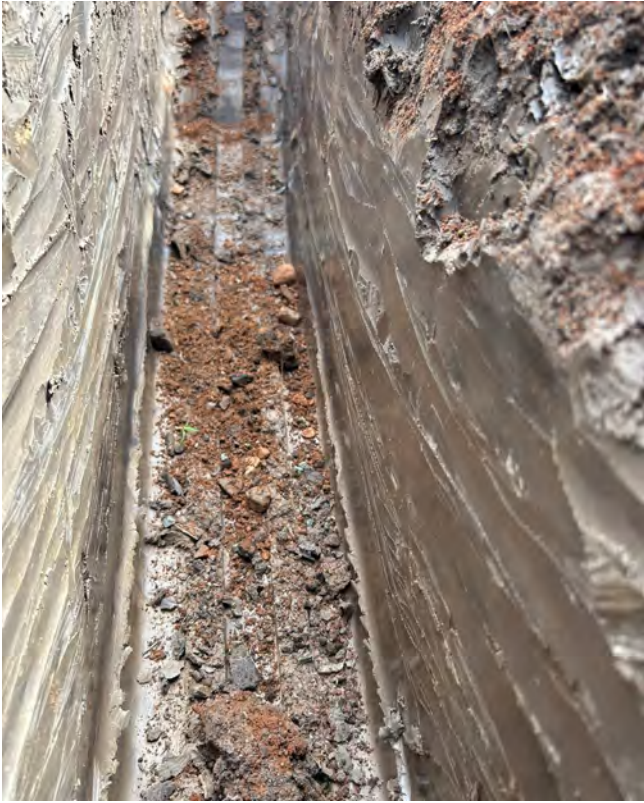
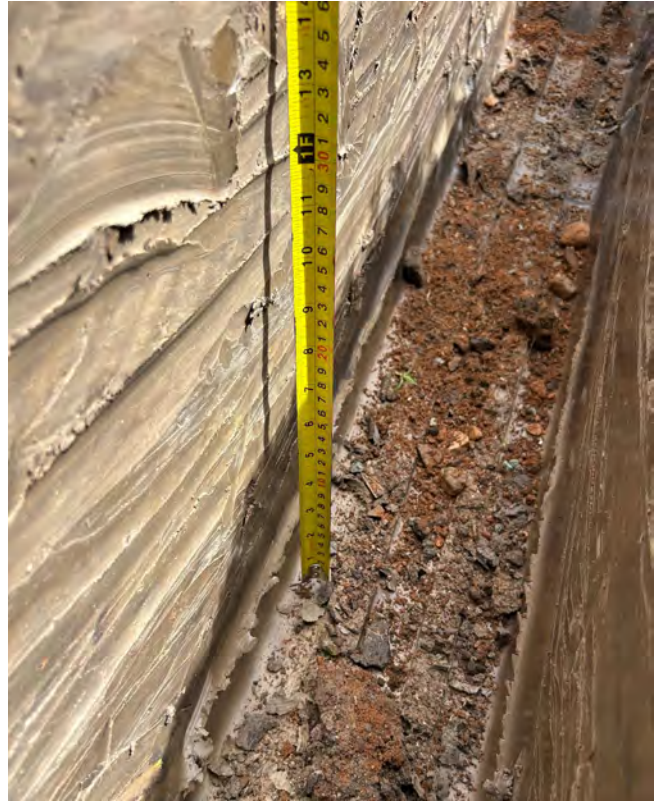
TP1 - Profile

TP1 Profile

Drilling Method	Water	DCP Blows	Depth (m)	Soil Origin	Graphic Log	Classification Code	Material Description	Samples	Testing	
									PP	SPT
Excavator		4	0.15	Controlled Pavement Fill		GM	Silty Sandy GRAVEL GM: fine to coarse sized, fine to coarse grained sand, reddish brown, wet, loose, **Cobbles Present.			
		3		Natural		CI	Natural Silty CLAY CI: medium plasticity, trace fine to coarse sized gravel, greyish brown, wet to moist to dry with depth, soft.	Disturbed Sample		
		5								
		4								
		7								
		10								
		9								
		12					TP1 Refusal at 0.7 m (Hard Ground Refusal with 1.7t Excavator)			
		12

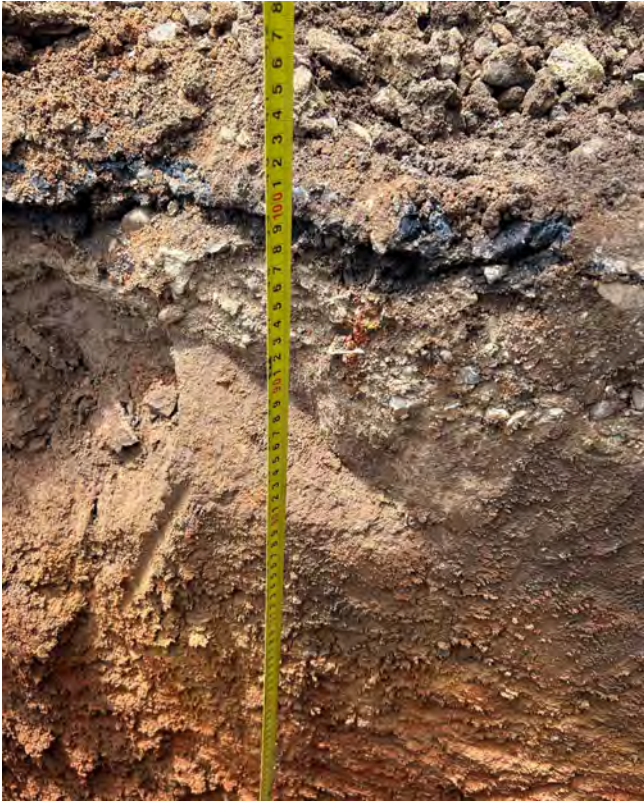
Soil Profile - TP2

Drilling Method	Water	DCP Blows	Depth (m)	Soil Origin	Graphic Log	Classification Code	Material Description	Samples	Testing	
									PP	SPT
Excavator			0.024	Bitumen		ASP	Bitumen ASPHALT: black.			
			0.1	Controlled Pavement Fill		GM	Sandy Silty GRAVEL GM: fine to coarse sized, fine to coarse grained sand, reddish brown, wet, loose, **Cobbles Present.			
				Natural		CL	Natural Silty CLAY CL: low plasticity, with fine to medium grained sand, reddish brown to greyish brown with depth, moist, stiff to very stiff with depth.	Disturbed Sample		
			1							
			2							
			3							
			4							
			4							
			8							
			10							
		9					TP2 Terminated at 1 m

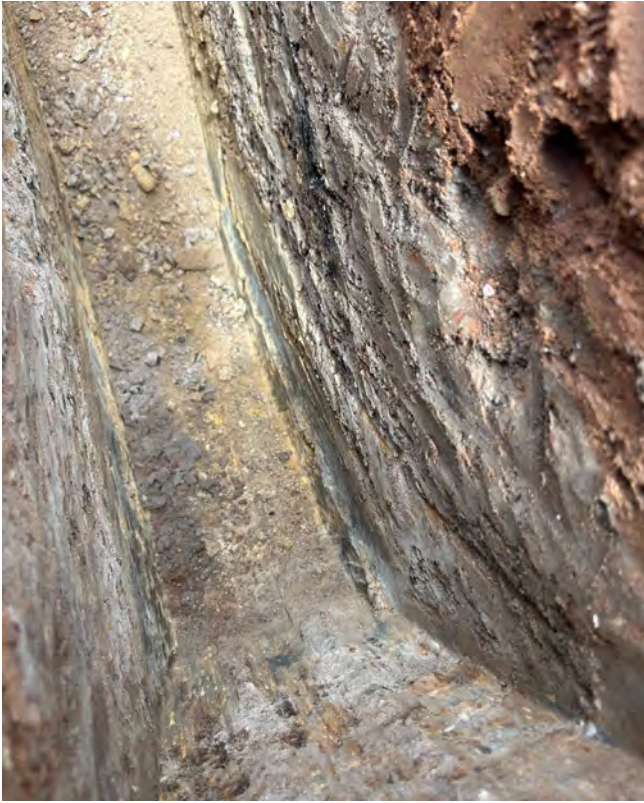
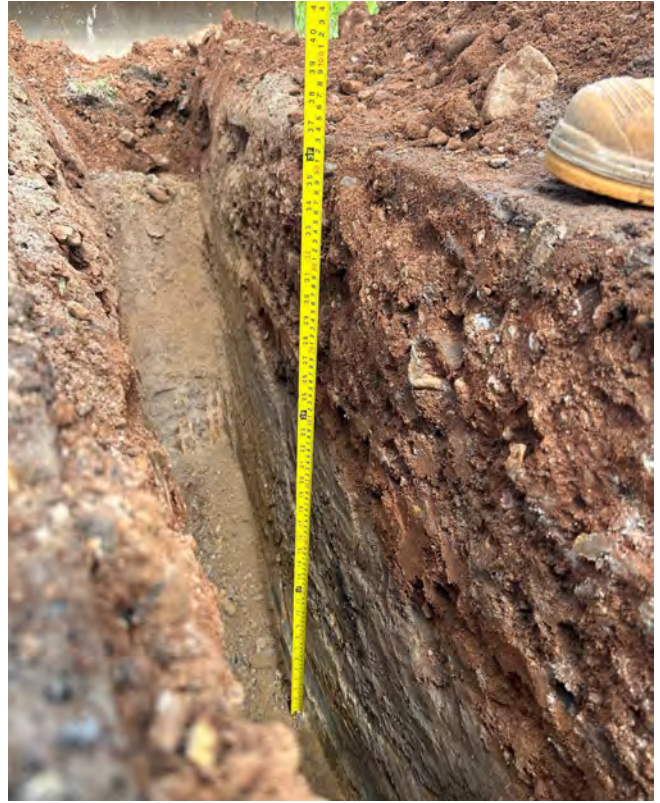
Soil Profile - TP3

Drilling Method	Water	DCP Blows	Depth (m)	Soil Origin	Graphic Log	Classification Code	Material Description	Samples	Testing	
									PP	SPT
Excavator			0.03	Bitumen		ASP	Bitumen ASPHALT: black.			
				Controlled Pavement Fill		GM	Silty Sandy GRAVEL GM: fine to coarse sized, fine to coarse grained sand, reddish brown, wet, loose, **Cobbles Present.			
		5	0.23	Natural		SP	Natural Silty SAND SP: poorly graded, fine to coarse grained, reddish brown to greyish brown with depth, moist, very dense, ** Cobbles present.	Disturbed Sample		
		7								
		8								
		7	0.55	Natural		CH	Natural Silty CLAY CH: high plasticity, with fine to medium grained sand, greyish brown/yellowish brown mottled, moist, very stiff to hard with depth.			
		8								
		12								
		13								
							TP3 Refusal at 0.92 m (Hard Ground Refusal 1.7t Excavator)

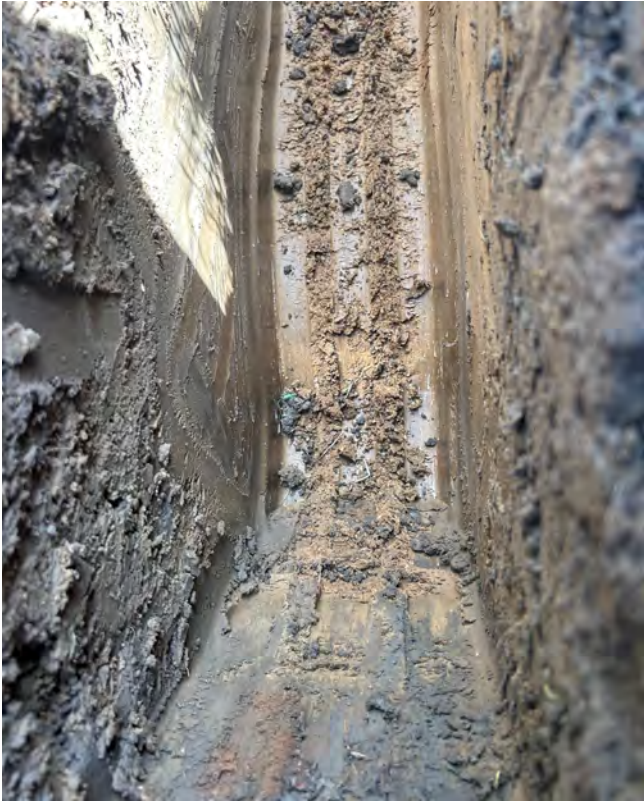
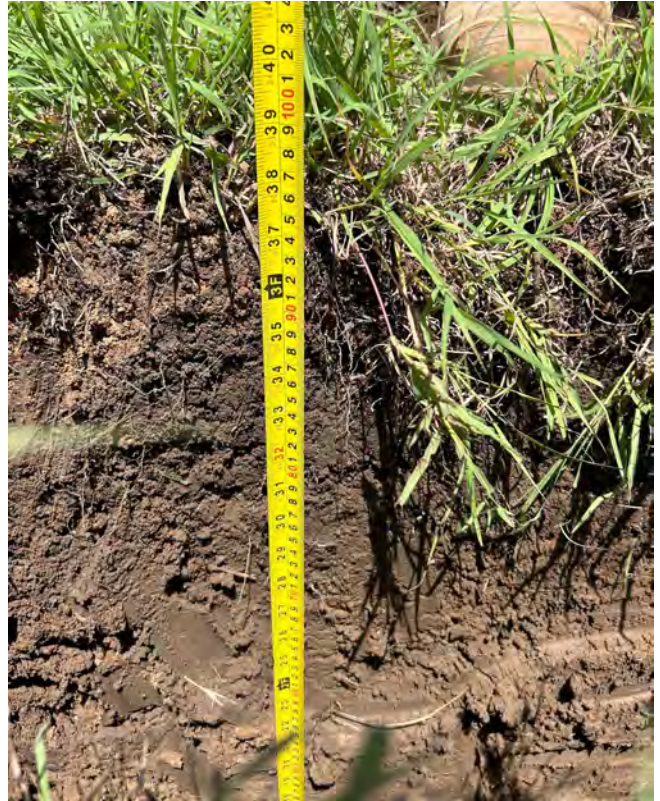
Soil Profile - TP4

Drilling Method	Water	DCP Blows	Depth (m)	Soil Origin	Graphic Log	Classification Code	Material Description	Samples	Testing	
									PP	SPT
Excavator			0.1	Controlled Pavement Fill		GM	Silty Sandy GRAVEL GM: fine to coarse sized, fine to coarse grained sand, reddish brown, wet, loose, **Cobbles Present.			
		2		Natural		CL	Natural Silty CLAY CL: low plasticity, with fine to medium grained sand, dark brown to brown with depth, moist, stiff to very stiff with depth.	Disturbed Sample		
		3								
		3								
		4								
		6								
		8								
		10								
		10								
		11								
							TP4 Terminated at 1 m

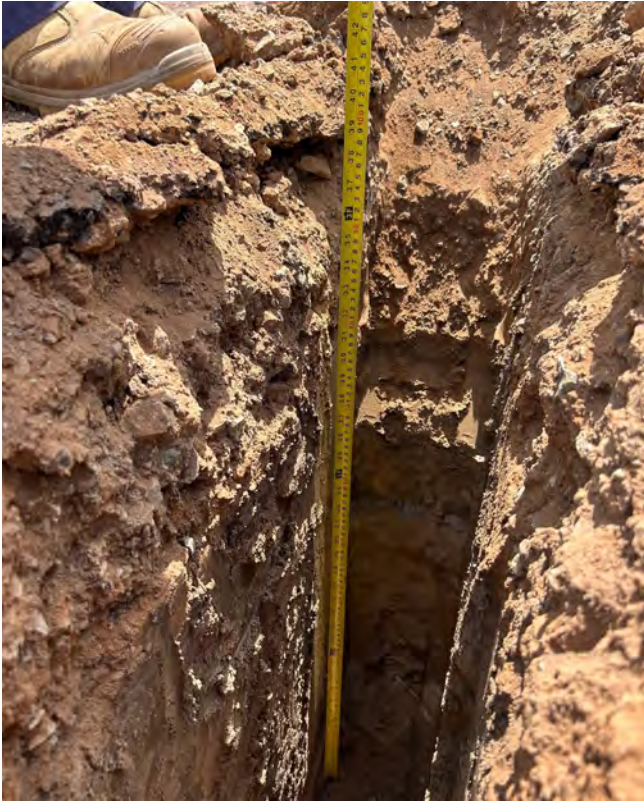
Soil Profile - TP5

Drilling Method	Water	DCP Blows	Depth (m)	Soil Origin	Graphic Log	Classification Code	Material Description	Samples	Testing	
									PP	SPT
Excavator			0.025	Bitumen		ASP	Bitumen ASPHALT: black.			
			0.2	Controlled Pavement Fill		GM	Silty Sandy GRAVEL GM: fine to coarse sized, fine to coarse grained sand, reddish brown, wet, loose, **Cobbles Present.			
				Natural		CI	Natural Silty CLAY CI: medium plasticity, with fine to medium grained sand, greyish brown to brown with depth, moist, stiff to very stiff with depth.	Disturbed Sample		
							TP5 Terminated at 1 m

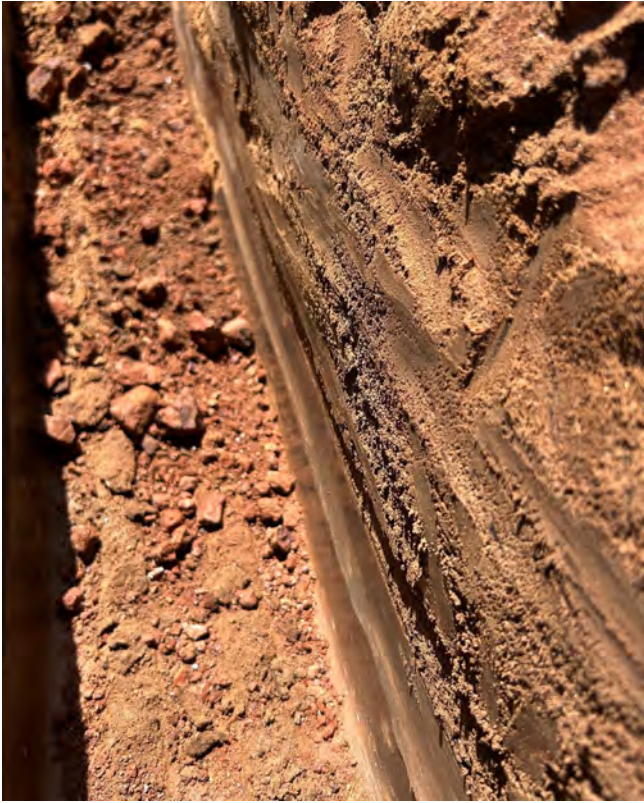
Soil Profile - TP6

Drilling Method	Water	DCP Blows	Depth (m)	Soil Origin	Graphic Log	Classification Code	Material Description	Samples	Testing	
									PP	SPT
Excavator			0.1	Controlled Pavement Fill		GM	Silty Sandy GRAVEL GM: fine to coarse sized, fine to coarse grained sand, reddish brown, dry, dense, **Cobbles Present.			
		9		Natural		CL-CI	Natural Silty CLAY low to medium plasticity, trace fine to coarse sized gravel, light brown, moist to dry with depth, very stiff.	Disturbed Sample		
							TP6 Refusal at 0.63 m (Hard Ground Refusal with 1.7t Excavator)

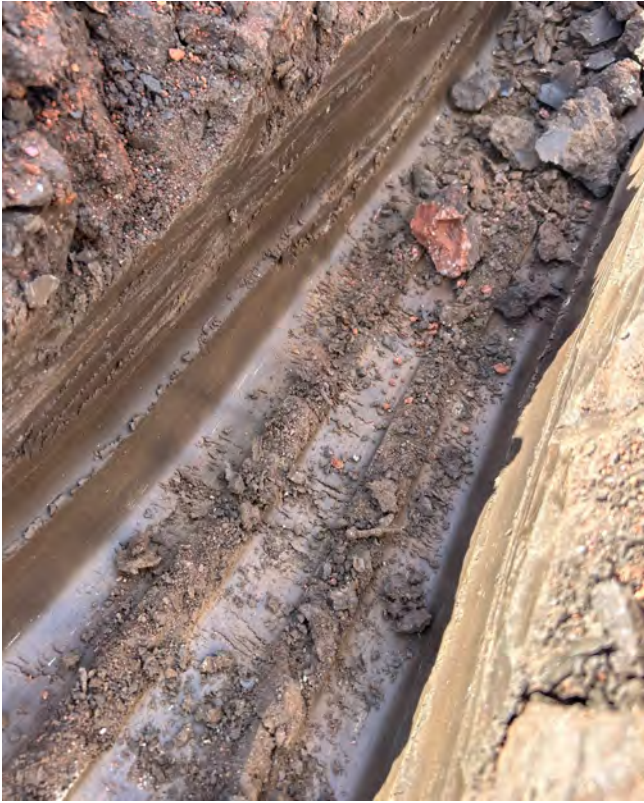
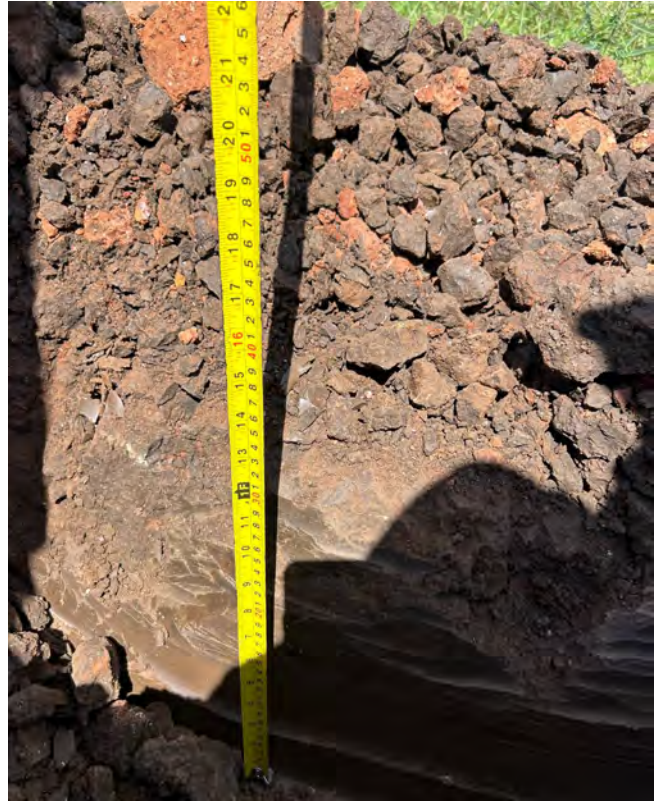
Soil Profile - TP7

Drilling Method	Water	DCP Blows	Depth (m)	Soil Origin	Graphic Log	Classification Code	Material Description	Samples	Testing	
									PP	SPT
Excavator		0 5 10 15 20	0.1	Controlled Pavement Fill		GM	Silty Sandy GRAVEL GM: fine to coarse sized, fine to coarse grained sand, reddish brown, wet, loose, **Cobbles Present.			
				Natural		CH	Natural Silty CLAY CH: high plasticity, trace fine to coarse sized gravel, black to dark brown with depth, dry, very stiff to hard with depth.	Disturbed Sample		
							TP7 Refusal at 0.45 m (Hard Ground Refusal with 1.7t Excavator)

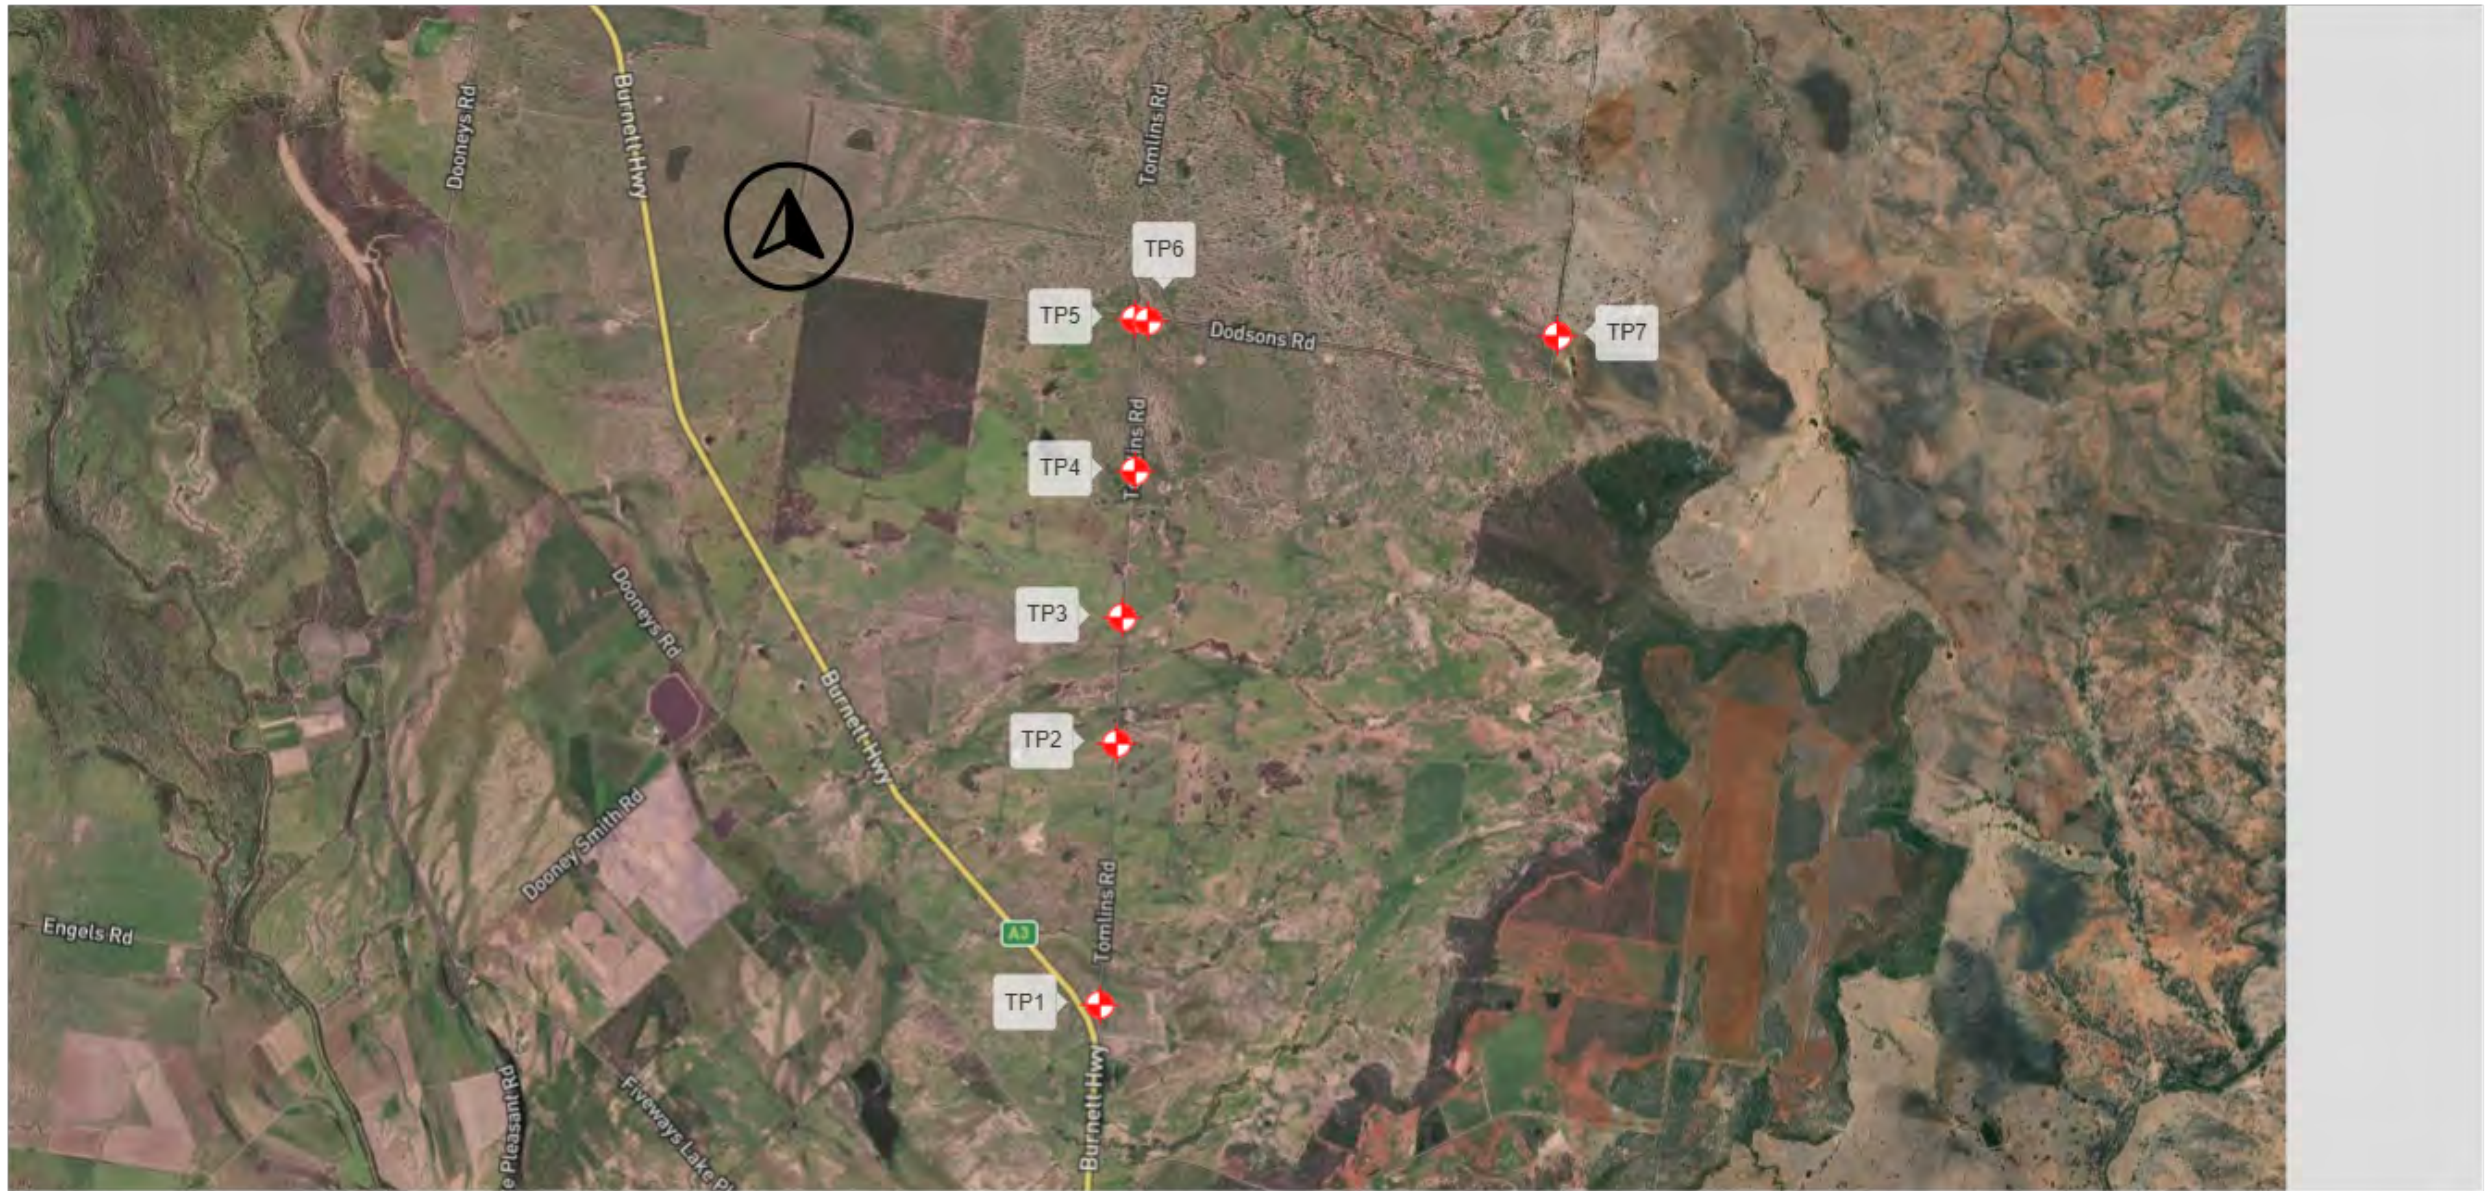
# Tomlins Rd, Goovigen QLD 4702, Australia

The approximate locations of the respective investigation sites referred to above are shown on the attached Site Plans (Appendix C). Test locations were measured using hand held GPS to an accuracy of 5 m and summary of Testpit locations are presented in Table 2.
